Arkema Facility - Harvey Response

Crosby, TX
Arkema Inc.
September 3, 2017
Project #109489 Summary

1.0 Introduction

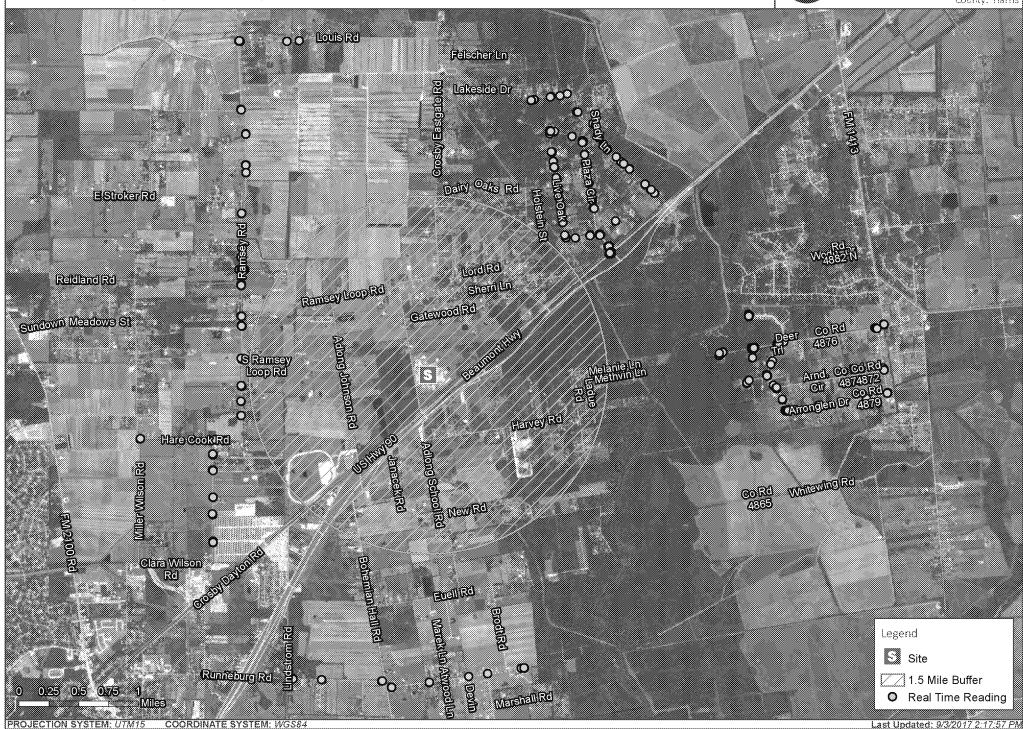
Attachment B Handheld Real-time Air Monitoring Locations

Hand-held Real-time Reading Locations

Harvey Response - 06:00 September 2, 2017 to 06:00 September 3, 2017

All real-time air monitoring instrumentation was calibrated per the manufacturer's recommendations prior to air monitoring. Handheld, real-time air monitoring was conducted for benzene, cumene, and volatile organic compounds (VOCs) using RAE Systems and Gastec instruments. Additionally, combustion byproducts potentially associated with fire smoke, such as particulate matter ($PM_{2.5}$), nitrogen dioxide ($PM_{2.5}$), and sulfur dioxide ($PM_{2.5}$) were assessed. **Table 1** summarizes the data for all real-time air monitoring readings recorded in Crosby, TX from 06:00 on September 2, 2017 through 06:00 on September 3, 2017. Maps of real-time air monitoring locations are provided as **Attachment B**.

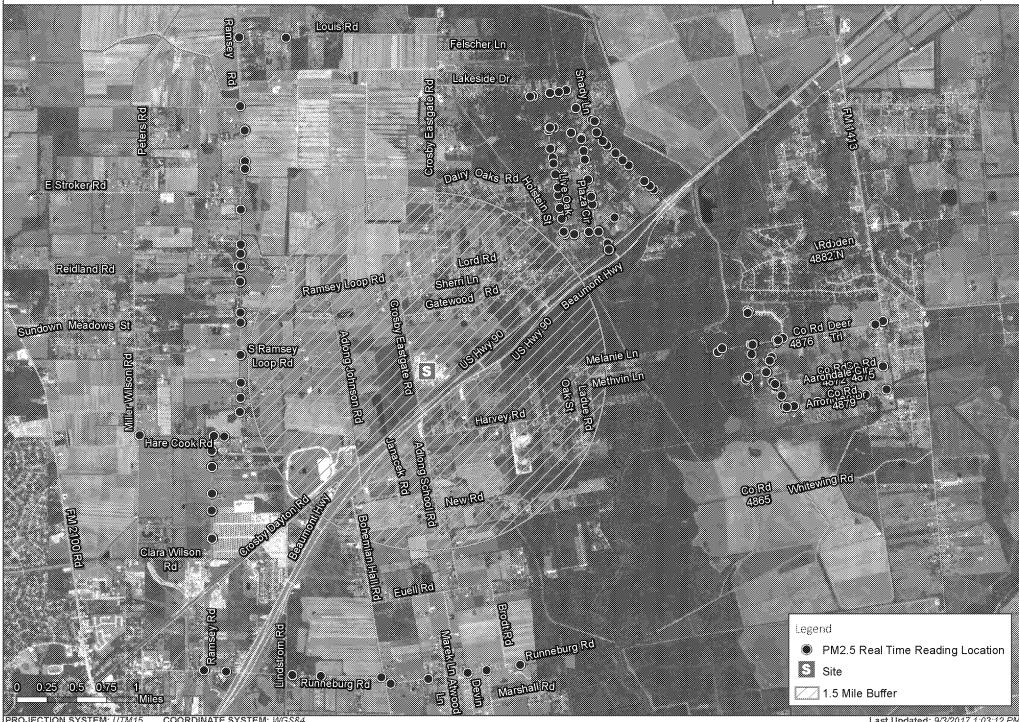
PM2.5 Hand-held Real-time Reading Locations

Harvey Response - 06:00 September 2, 2017 to 06:00 September 3, 2017

Analyte	Instrument	Number of Readings	Number of Detections	Range of Detections*
Benzene	UltraRAE	47	0	< 0.025 ppm
Cumene	Gastec Tube 122L	2	0	< 2.0 ppm
NO_2	MultiRAE Plus	68	0	< 0.1 ppm
PM _{2.5}	AM510	142	142	0.022 - 0.13 mg/m ³
	Dusttrak	58	58	0.017 - 0.12 mg/m ³
SO ₂	MultiRAE Plus	81	0	< 0.1 ppm
VOCs	MultiRAE Plus	211	5	0.6 - 1.4 ppm

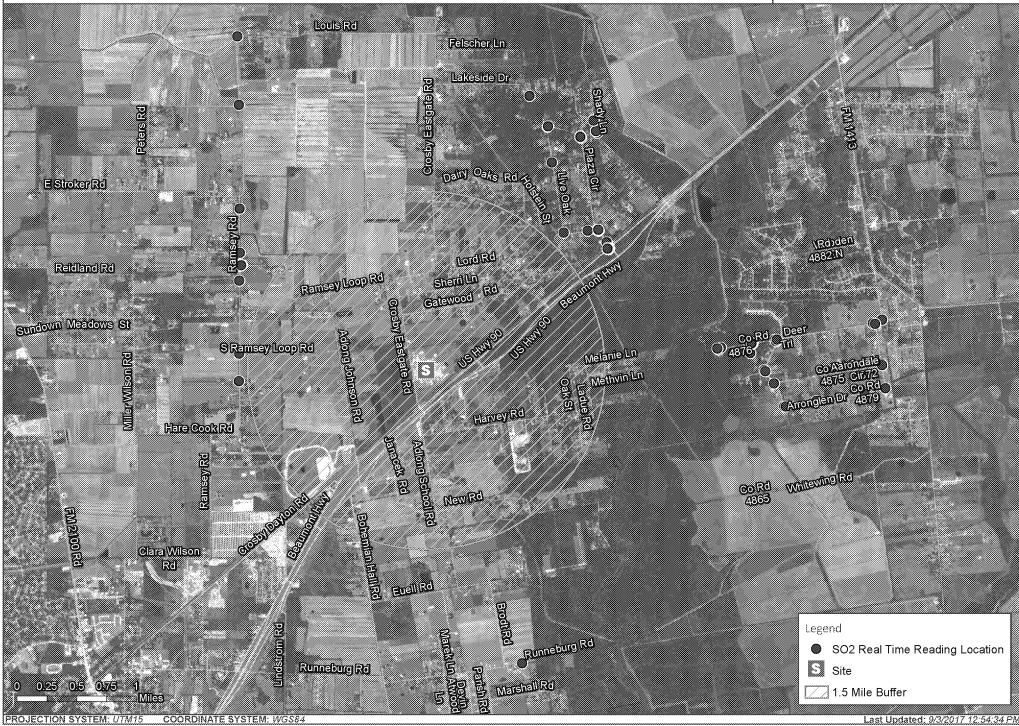
Sulfur Dioxide Hand-held Real-time Reading Locations

Harvey Response - 06:00 September 2, 2017 to 06:00 September 3, 2017

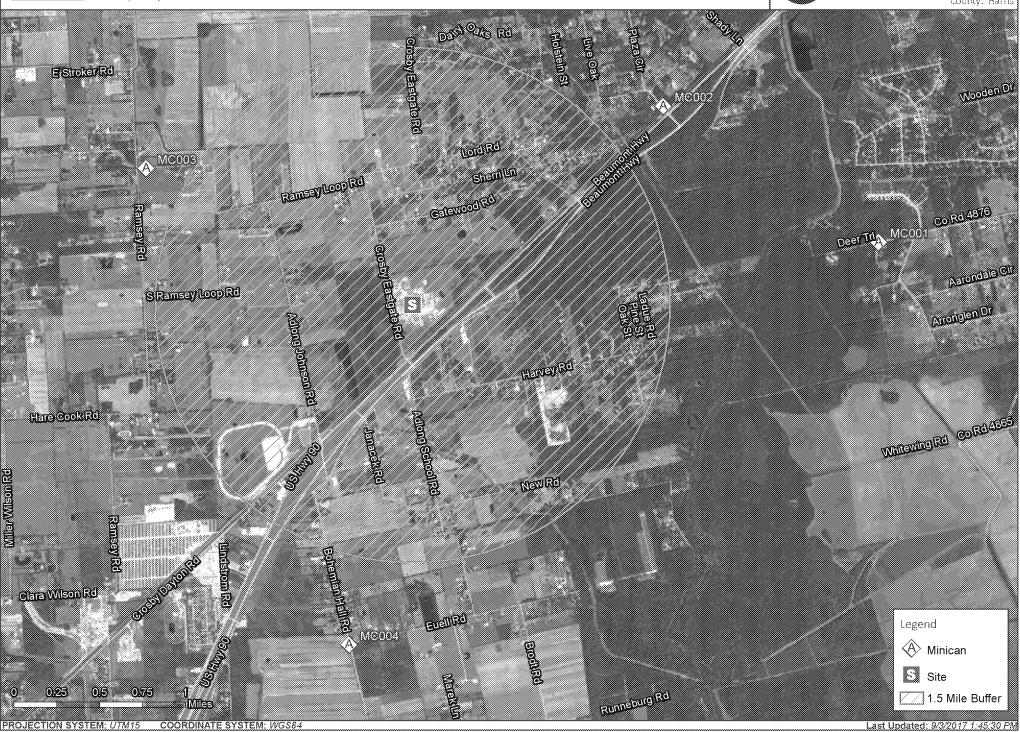
Attachment C Map of Analytical Air Sampling Locations

Analytical Air Monitoring Station Locations as of September 3, 2017

Harvey Response

To supplement real-time air monitoring, CTEH® deployed areas along the perimeter of the evacuated area within the community. Evacuated canister (Minican™) samplers were regulated to collect air evenly over a 24-hr period. Analytical air samples will be submitted to SGS Galson Laboratories, an AIHA-accredited laboratory, for analysis using EPA Method TO-15. A map highlighting the analytical air sampling locations is provided as **Attachment C**. Analytical Air Sampling Results will be reported upon receipt from the laboratory.

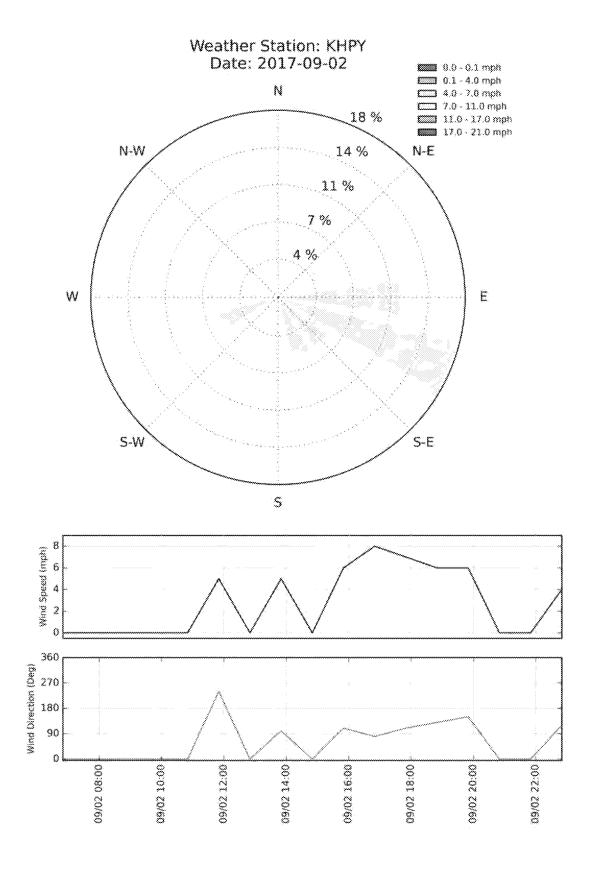
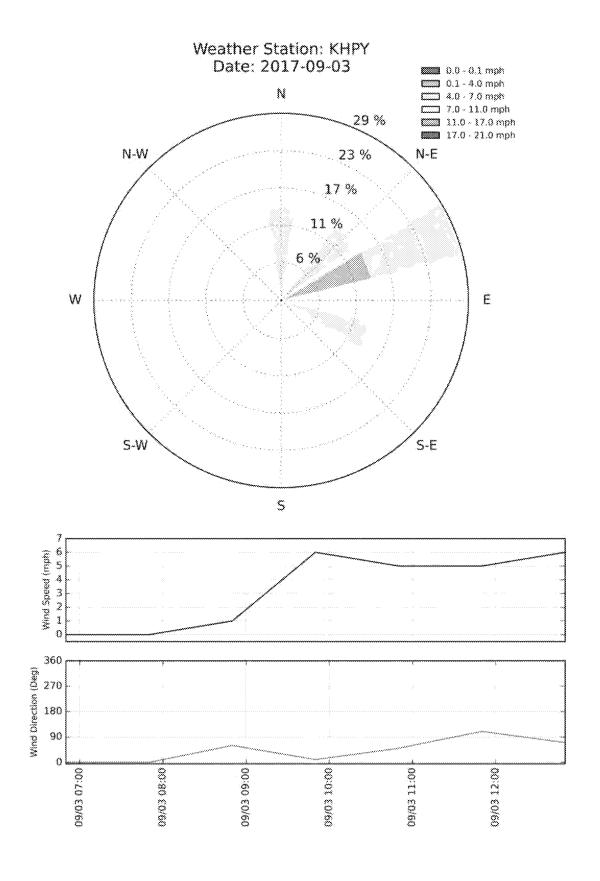
Attachment D KHPY Windrose

(Highland Park Airport - 12.5 miles SSE of Site)
